## The Cathedral of Vilnius: Problems and Features of Natural Conditions

**Abstract.** The Cathedral of Vilnius is one of the main architectural monuments in Lithuania. This structure was built in unfavourable geological conditions. Due to this reason, the foundation of the building subsides; there occur wall deformations and cracks. Preservation of the building is today's urgent problem. When evaluating the geologic environment from the perspective of engineering, construction works require deep analysis of the following key environment components and discuss them: relief, soils of geologic structure and their geotechnical properties, conditions of underground water occurrence and geological processes, and condition of the foundation. The article provides the brief history of construction and reconstruction of the Cathedral based on archival studies, the description of engineering geological conditions, and the archeological and historic material of the evaluation of the foundation.

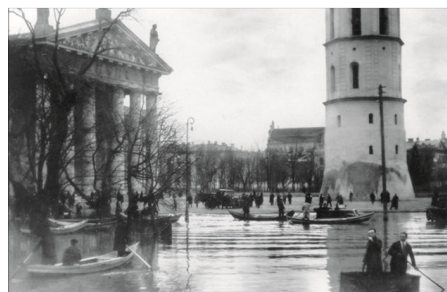
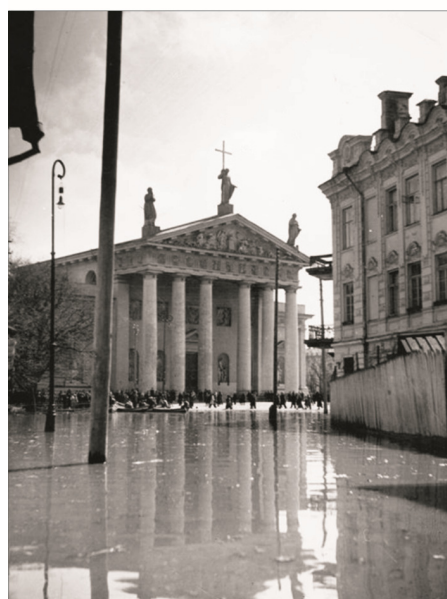
In the spring of 1931, during the flood of the Neris, the water level critically and instantly raised. On the 28 of April, 1931, the highest level water in the history of the city was measured – it reached 825 cm. Such flood as in 1931 happens once in a century only. Water covered the Cathedral Square; undergrounds of Cathedral were flooded to the ceilings (Fig. 8).

The floor in the lateral nave and the St. Kazimieras Chapel hollowed, multiple cracks occurred in the walls and vaults, columns of the western portico leaned to the west. Measurements revealed that the centre of gravity of the portico columns moved from the vertical by 7 cm. The foundation block of the portico columns cracked and divided into three pieces. Emergency status was announced and the Cathedral was closed for public.

Fig. 8. The Cathedral Square during the flood of 1931 (photo from Narodowe archiwum cyfrowego 2016)

On the 17 of July, 1931, the Vilnius Basilica Saving Committee was convened together with several special commissions (the key ones – Technical and Art Commissions). Leading future research and preserving works was assigned to Juliusas Klosas (Juliusz Klos), his deputy for research was the architect Janas Pekša (Jan Peksza). From July of 1931 to the summer of 1932, there were geological researches performed, followed with measurements of the building, observations of the level of ground water and its ground. The floor was taken out from the middle of the building and 50 pits (up to 5÷8 m in depth) were dug. In 1932–1937, under

management of eng. H. Wąsowicz invited from Warsaw, reinforcement of the Cathedral foundation and underground part of the building was performed. 279 piles of ferroconcrete, 11÷15 m in length, were established under the foundation (Fig. 9).

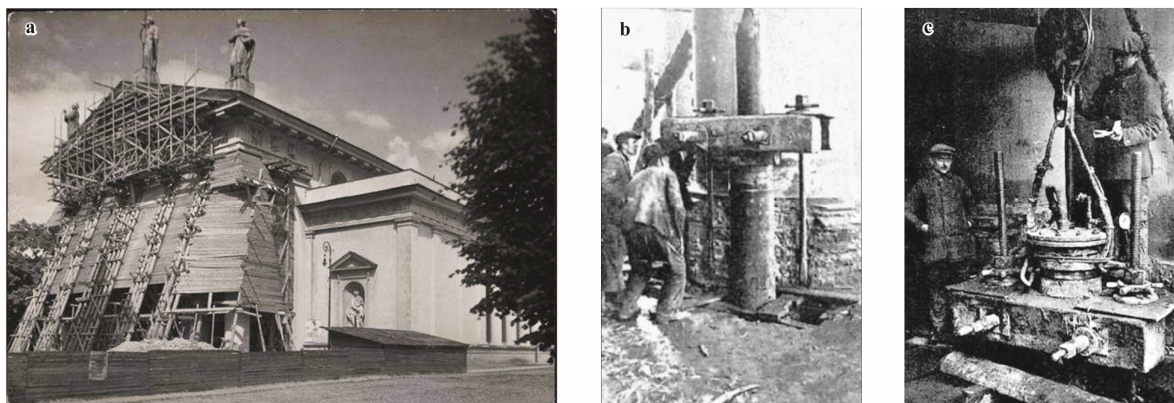
Fig. 9. Reinforcement of the Cathedral foundation (a). Pile placing (b, c) (Wąsowicz 1933)

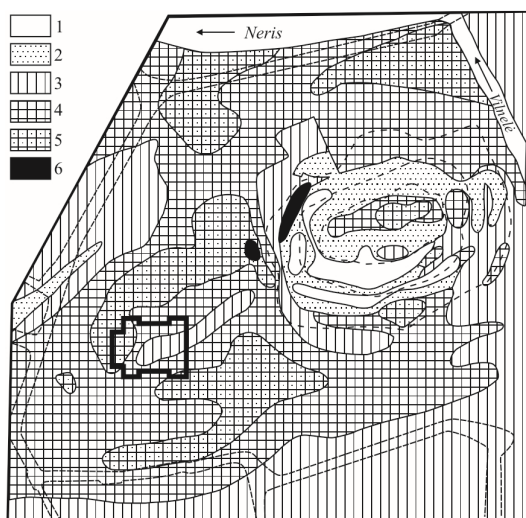
Fig. 15. The map of the thickness of technogenic and bog sediments of the studied territory (acc. Monstvilas 1976): 1 – < 1 m, 2 – 1÷2 m, 3 – 2÷4 m, 4 – 4÷6 m, 5 – 6÷8 m, 6 – > 8 m

From the engineering geological point of view, restoration of the natural relief is more significant. Considering the data of researches between the wars and after war, it could be stated that the initial relief is complicated. The relative heights differ up to 4 m in average. The territory distinguishes with a heightening of the old relief, several meters in length (2–3 m), going from NE to SW and lowering towards south west till the southwestern corner of the Cathedral. This geomorphological element is diversified with erosive forms. Supposedly, these can be ravines or gullies. These depressions are seen in the southwestern corner of the Cathedral (the St. Kazimieras' Chapel) and in the north-eastern corner (the sacristy), also in the north-western (the Valavičiai and Vladislovas Chapels) and in the western sides of the Cathedral. All these erosive forms are filled with various and weak soils. The map of the thickness of technogenic sediments of the Vilnius castle area, prepared by K. Monstvilas in 1976, is given in Figure 15.

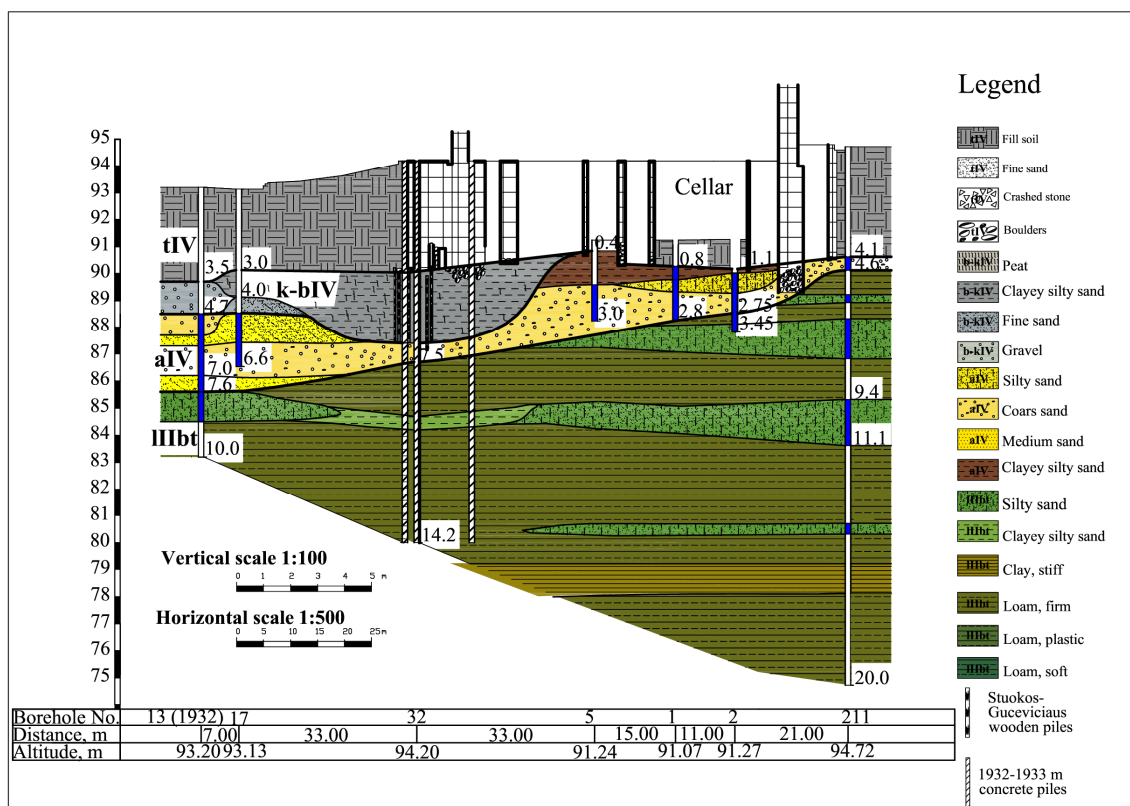
Fig. 17. Engineering geological cross-section II-II under the Cathedral (according to Monstvilas 1973)

The geological cross-section of the area consists of technogenic soil (tIV), boggy sediments and cultural layer (k-bIV), alluvial sediments (aIV), Dainava–Žemaitija intermoraine sediments (IIIbt) (Figs 17, 18, 19).

Cultural and boggy sediments (k+bIV) are enriched with different domestic waste of the cultural layer and occurs under the layer of technogenic soil up to 4.5÷8.5 metres in depth. They spread in the whole territory of the Cathedral, except for the eastern and central parts. Their thickness varies from 1.5 to 4.5 metres. The thickest part is at the north-western corner of the Cathedral. According to the structure, these are peaty sandy clays and peat with admixture of domestic waste. The unit weight of sediments is 9÷12 kN/m<sup>3</sup>, void ratio is 0.8÷1.9, moisture content – 24÷29%, cone resistance – 1÷2 MPa. The soil is loose, weak.

Alluvial sediments (aIV) contain sand gravel, sands of various coarseness, and sandy loam in rare cases. These sediments are widely spread in the whole area of the Cathedral, except for the north-western corner. They are found in the depth of 3.5÷6.8 metres. The ridge of the layer goes up in the eastern side of the Cathedral. The unit weight of soils is 18÷21 kN/m<sup>3</sup>, cone

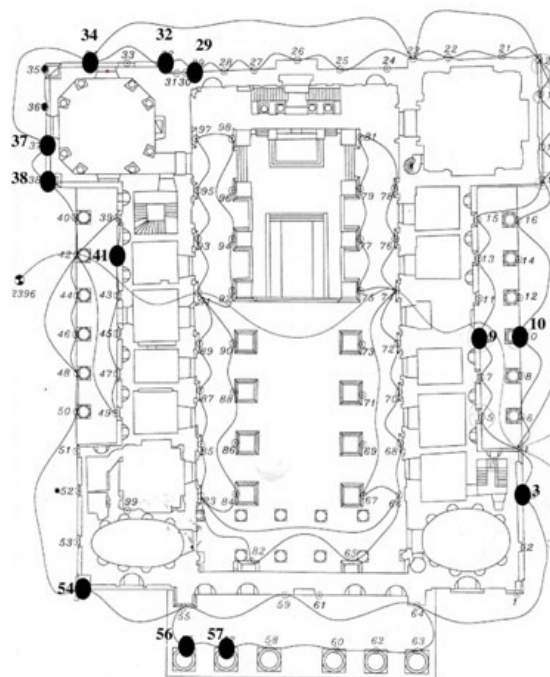
Fig. 20. Layout of marks of the Cathedral (Garška 2005)

Observations of settlements in the walls of the Cathedral started in 1971 and continued till 2005. The layout of marks of observations in the walls of the Cathedral is given in Figure 20. The picture highlights only those marks that reveal the largest depressions. The sacristy undergoes the biggest deformations (29–38 marks). Here depressions reach from 2 to 10 mm. Depression in the middle of the southern wall (9–10 marks) is up to 7 mm and in the northern corner of the portico (54–57 marks) reaches up to 4.5–6.5 mm. (Fig. 21).

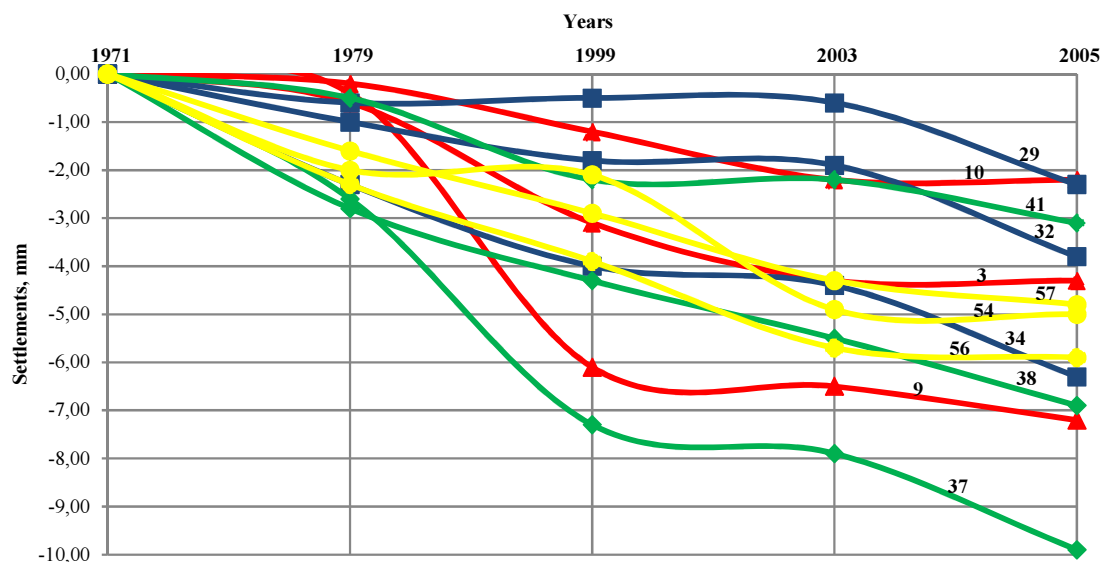
Fig. 21. Settlements of the walls of the Cathedral (mm): red – the southern wall, blue – the eastern wall, green – the northern wall, yellow – the western wall, the portico. 29 – mark number (according to Garška 2005)

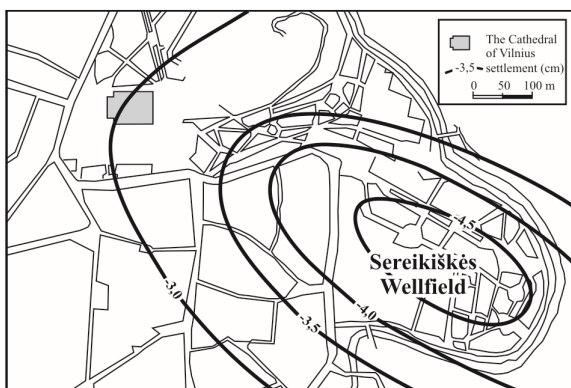
The Cathedral and surrounding territory gets into the oldest area of Vilnius waterfield. This waterfield uses confined underground water occurring in the depth of 30–32 m (the Sereikiškės Park). The distance from the watering-place to the Cathedral is around 620 m. The maximum water level lowering happened in 1959–1960 and reached approximately 10.5 m. According to the calculations of K. Dundulis *et al.* (2002), upon such cone of depression, the ground surface depression at the Cathedral Square could be around 3 cm (Fig. 22).

Fig. 22. The plan of the ground surface depression affected by the Sereikiškės water-place (Dundulis et al. 2002)
