Deformations of foundations of windplant installation crane sites and their reasons

Deformations of installation crane sites and investigation programme

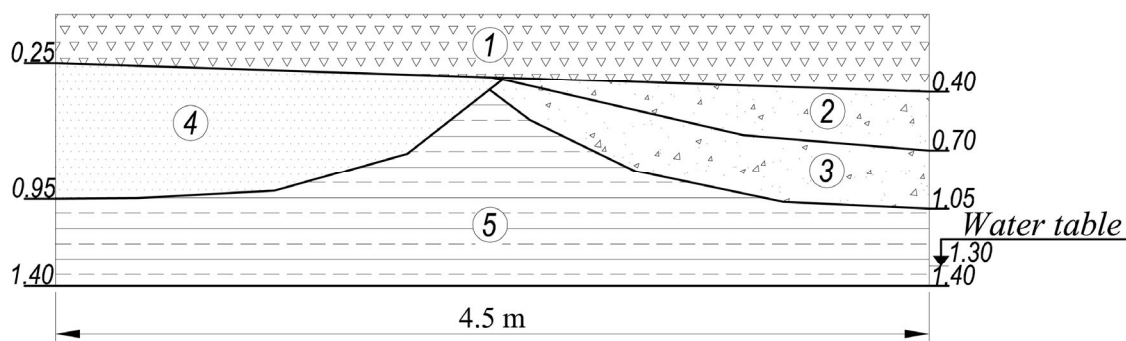
On No. 19 site, a 1.0 m deep excavation was made (Figure 1). The excavation consists of three layers. The first one consists of a layer of compacted gravel; the second one consists of cold-resistant layer consisting of sandy soil, which according to grain size is from gravelly sand to low-gravel medium coarse sand. This layer is smooth and reaches the depth of ~ 0.8 m. The third layer is the base of the clay soil. The results for moisture content and density are given in Table 4. On this site, sandy soil is low in water, S_r ranges from 0.17 to 0.43. Minimum values are fixed in the upper part of the layer, and the bottom is close to wet soil, where S_r is 0.43. The clay soil is very stiff according to the consistency test.

Figure 1. Schematic section of excavation of No. 19 wind power plant: 1 – technogenic gravel; 2 – technogenic gravelly fine sand; 3 – technogenic gravelly fine sand, with clay, saturated; 4 – technogenic coarse sand with cobbles; 5 – natural soil (silty clay, with fine sand)

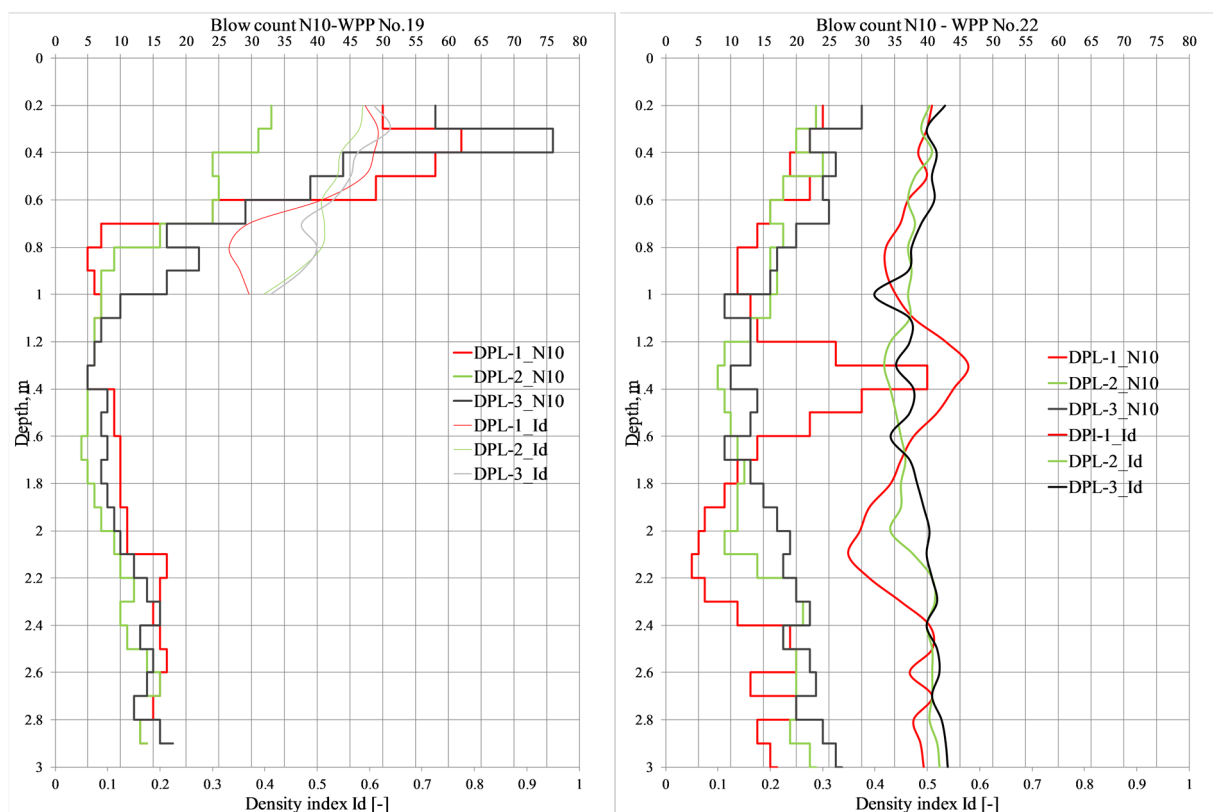
In April 2015, dynamic probing light was applied at different locations on No. 19 and 22 wind power plant crane installation sites, three on each. All three investigations on No. 19 power plant site showed that the upper part of the soil, up to the depth of $0.6 \div 0.7$ m, was denser compared to the lower layer, which was much weaker. Having made a 4.5 m long excavation at a depth of 1.8 m, the groundwater level was recorded at a depth of 1.3 m. The density index I_d is calculated only for the upper part and should be considered with care, because having made the excavation, very volatile soil is visually determined. In some places, under gravel, sand or medium coarse sand is loose, but in the middle part of the excavation, there is found a natural clay soil (Figure 1). Therefore, numerical I_d values may be inaccurate because the soil in the test site is volatile while the calculation of I_d for the clay soil is usually not done.

The results of dynamic probing light investigation of the power plant No. 22 shows that the soil is of medium density, with a slight weakening from the depth of $0.4 \div 0.6$ m. Weakness is associated with the groundwater level. After the excavation was made, it was found out that the top of it was made up of a 24 cm thick layer of gravel and sand beneath it. The excavation depth – 1.20 m. The water settled at a depth of 1.05 m. The results of dynamic probing light investigations are presented in Figure 2.

Figure 2. Results of Dynamic Probing Light of the foundations of wind power plants No. 19 and No. 22
