Drukteinis S, Bilvinaite G and Galler K (2025)  
Case Report: ProRoot MTA degradation in a  
compromised tooth: secondary trauma and  
acidic microenvironment leading to  
retreatment with biodentine.  
Front. Dent. Med. 6:1686600.  
doi: 10.3389/fdmed.2025.1686600

# Case Report: ProRoot MTA degradation in a compromised tooth: secondary trauma and acidic microenvironment leading to retreatment with biodentine

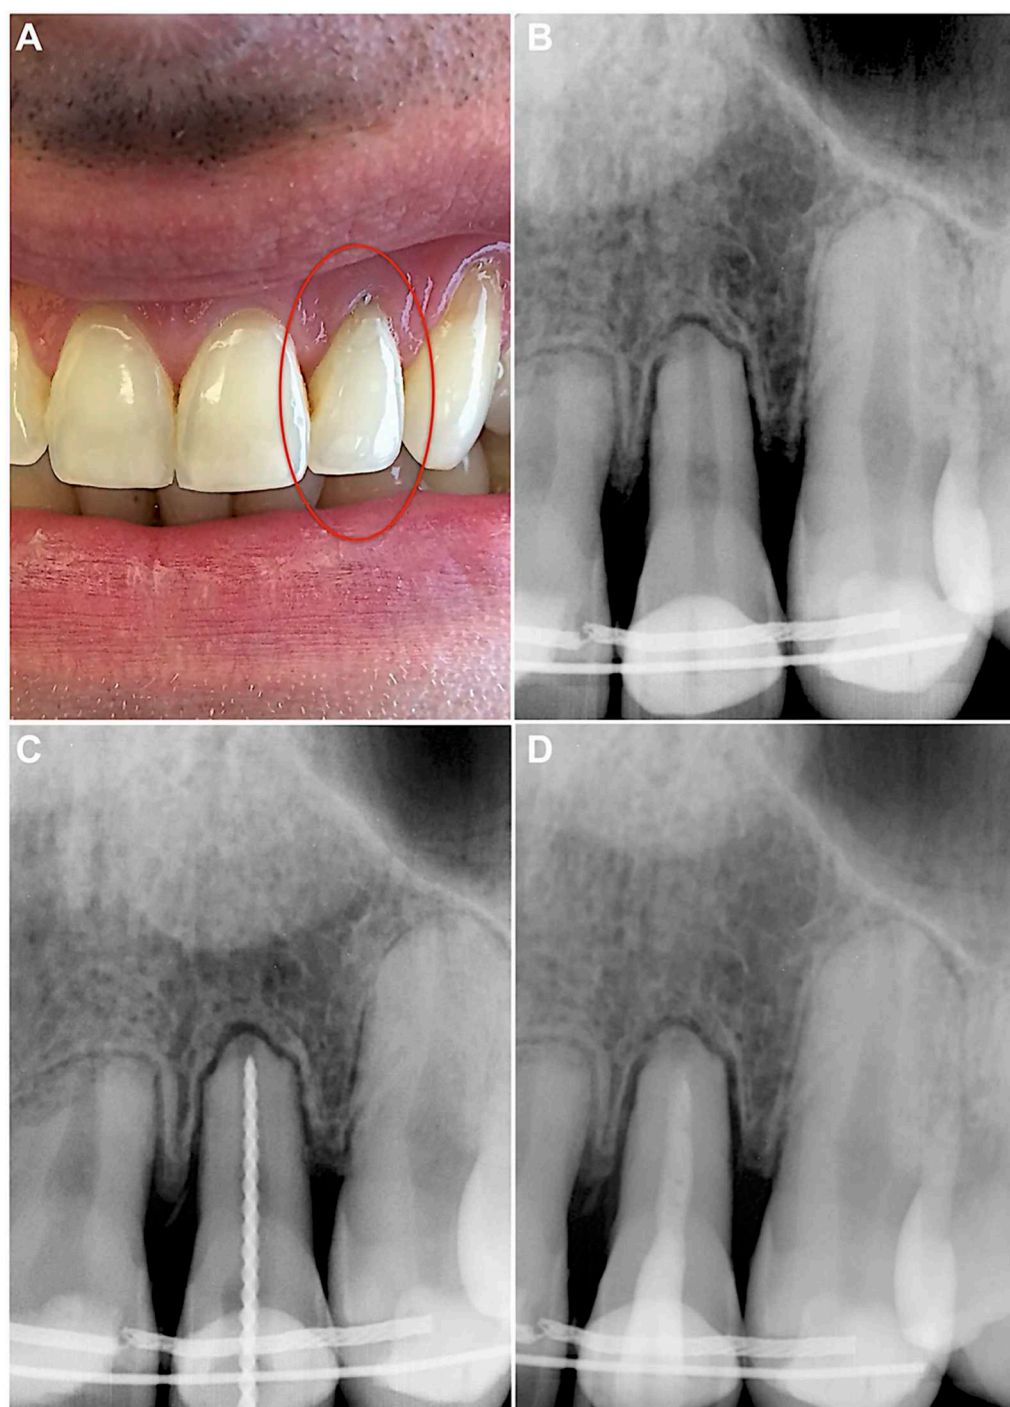
FIGURE 1

(A) Preoperative intraoral photo taken during the examination on the first visit. (B) Preoperative periapical radiograph revealing apical root resorption of teeth 21, 22, 23, and widened periodontal ligament of tooth 22. (C) Intraoperative periapical radiograph for WL determination with #45/0.02 K-File. (D) Postoperative periapical radiograph of cleaned and shaped root canal, filled with UltraCal XS paste. The access cavity was sealed with reinforced zinc oxide-eugenol restorative cement IRM.

During the anamnesis at endodontist, the patient indicated that bleeding from the gingival sulcus was visible at tooth 22 instantly after the injury. The tooth was painful to touch and biting, and the sharp edge of the broken fixed wire retainer was felt. The patient underwent orthodontic treatment for 3 years and was currently in the retention phase for 4 months. Upon examination, no extraoral and intraoral changes were observed ([Figure 1A](#)). No tenderness to percussion was detected for teeth 21 and 23, and the sensitivity to cold and heat stimulus was normal. Meanwhile, tooth 22 was slightly tender to percussion, with a negative response to cold and heat tests. The periapical radiograph revealed the advanced apical root resorption of teeth 21–23 and a uniformly widened periodontal ligament of tooth 22 ([Figure 1B](#)).

The root canal working length (WL) was established using an apex locator and then confirmed radiographically ([Figure 1C](#)). The canal was shaped using hand files and the “apical box” technique up to #80/0.02 K-File (Dentsply Sirona, Ballaigues, Switzerland). After each instrument, the root canal was irrigated with 5 ml 3% sodium hypochlorite (NaOCl; Ultradent Products Inc., South Jordan, UT, USA) using disposable syringes and 29-G NaviTip needles (Ultradent Products Inc., South Jordan, UT, USA). At the end of shaping, a 5 ml 17% EDTA solution (Ultradent Products Inc., South Jordan, UT, USA) was used. The canal was then dried with sterile paper points and filled with calcium hydroxide paste UltraCal XS (Ultradent Products Inc., South Jordan, UT, USA) ([Figure 1D](#)). The endodontic access was sealed with intermediate restorative material IRM (Dentsply Sirona, Ballaigues, Switzerland). Finally, the broken retainer was fixed using light-cured resin-bonded composite Charisma (Kulzer GmbH, Hanau, Germany).

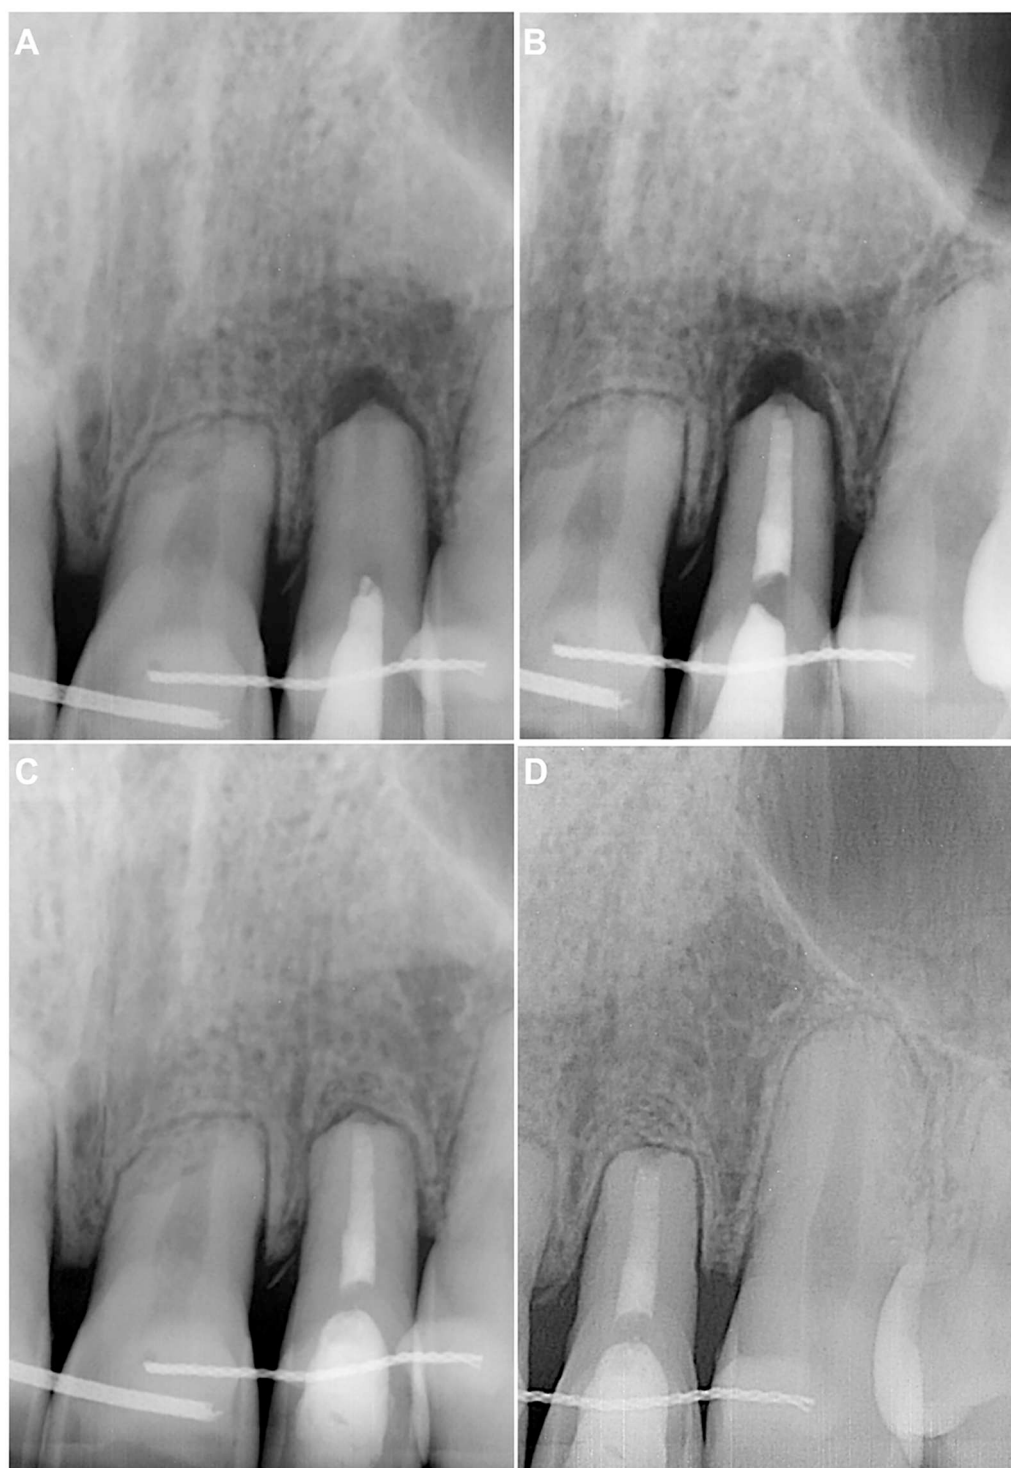
**FIGURE 2**

(A) Preoperative periapical radiograph demonstrating the empty root canal and periapical lesion of tooth 22. (B) Postoperative periapical radiograph after the root canal filling with ProRoot MTA White, followed by a wet cotton pellet and temporary restorative material IRM in the endodontic access cavity. (C) Six-month follow-up periapical radiograph showing a completely healed periapical lesion on tooth 22. (D) Eighteen-month follow-up periapical radiograph demonstrating no pathological changes in the tooth and periapical tissues.

material was mixed according to the manufacturer's instructions and condensed to a level 2 mm below the canal orifice. A moist sterile cotton pellet was placed, the access cavity was isolated with IRM, and the radiograph was taken to assess the quality of obturation (Figure 2B). After 48 h, the IRM and cotton pellet were removed, and fully set MTA was covered with a thin layer of glass ionomer cement Fuji IX (GC

The patient returned without complaints for scheduled follow-ups at 6 months (Figure 2C) and 18 months

(Figure 2D). No clinical or radiological signs of endodontic pathology were found on examination. The periapical lesion of tooth 22 was completely healed. The next follow-up was scheduled after a year.

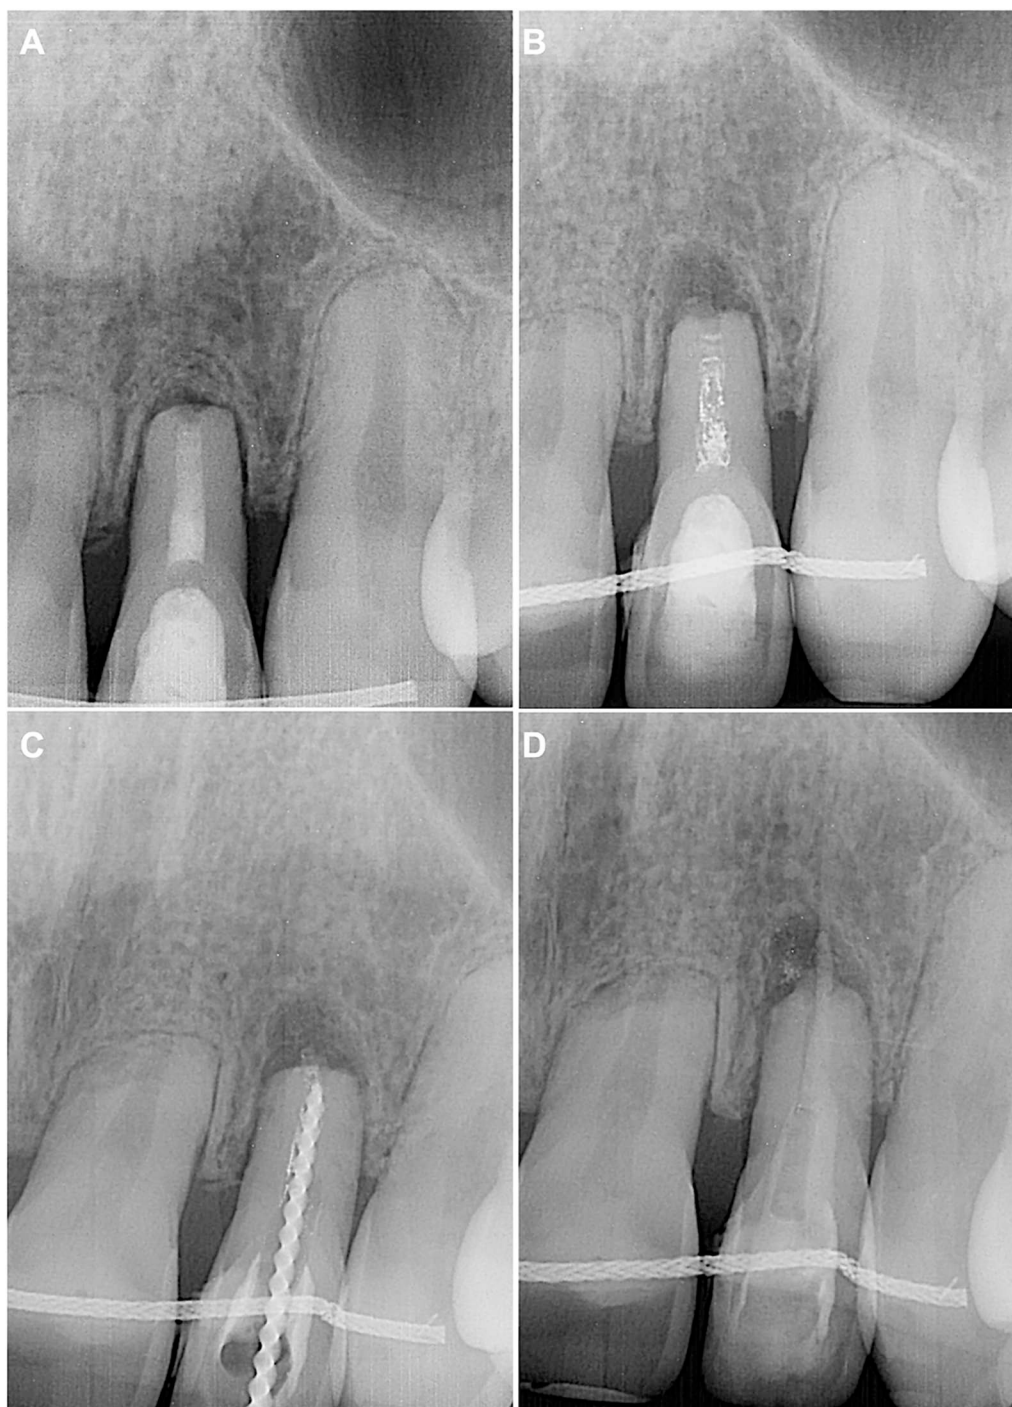
FIGURE 3

(A) Periapical radiograph performed during examination 2 weeks after the secondary dental trauma. (B) Eighteen-month follow-up periapical radiograph demonstrating changes in homogeneity of the root canal filling, along with a periapical lesion on tooth 22. (C) Intraoperative periapical radiograph for retreatment WL determination. (D) Intraoperative periapical radiograph after placing Biodentine in the apical and middle thirds of the root canal.

sensitivity on touching tooth 22. Upon examination, no extraoral or intraoral changes were observed. However, the tooth 22 was acutely tender to percussion. The periapical radiograph revealed a periapical lesion, along with a noticeable disintegration and decreased homogeneity of root canal filling (Figure 3B). Endodontic retreatment of the tooth was immediately initiated by removing the coronal restoration under the aforementioned protocol of local anaesthesia, isolation and disinfection. The procedure was performed under a dental operating microscope, which again revealed no signs of cracks or fractures. The dissolved MTA, discovered in the canal, was easily removed with hand K-files and the WL was regained (Figure 3C). The root canal was then reshaped up to #90/0.02 K-file, following the same irrigation protocol of NaOCl and EDTA as described above. The canal was filled with UltraCal XS paste, and the temporary filling IRM was placed.

The retention wire was intact, and tooth 22 was slightly tender to percussion. The periapical radiograph revealed a uniformly and slightly widened periodontal ligament (Figure 3A). A follow-up was scheduled 1 month later to monitor the situation.

The patient had no complaints after 2 weeks, and no clinical signs were found for tooth 22. Under local anaesthesia, the temporary crown seal was removed from the isolated and disinfected tooth. The irrigated (5 ml 3% NaOCl, 5 ml 17% EDTA, 5 ml sterile physiological saline) and dried canal was then filled with Biodentine (Septodont, Saint-Maur-des-Fosses, France), mixed according to manufacturer's instructions (Figure 3D). After the initial setting, the tooth was restored with light-cured resin-bonded composite Brilliant (Coltene-Whaledent, Allstetten, Switzerland).

Even mild dental trauma, such as subluxation, can disrupt the homeostasis of the local microenvironment due to periodontium damage and inflammatory response. In this clinical case, MTA was likely re-exposed to an acidic environment that was left initially unaddressed for several reasons: (I) there were no indications for root canal retreatment at that time; the patient was only scheduled for a regular follow-up, and (II) the alkalizing activity of calcium hydroxide is not a feature of fully set HCSC, such as ProRoot MTA, which had aged for 2 years by the time of secondary trauma. All HCSCs lack acid resistance, as the changes in physical and chemical properties have been repeatedly emphasized in the literature (14, 16). An acidic environment can initially impair the setting of HCSCs by inhibiting the formation of calcium hydroxide and calcium silicate hydrate (CSH) (14). Over time, low pH can induce the degradation of CSH, which is crucial for the strength and structural integrity (17). The decalcification of CSH begins with transformation into a lower Ca/Si ratio CSH at the pH below 8.8 and may continue until amorphous silica gel is left (18, 19). Thus, the disintegration of MTA observed at the follow-up of the secondary trauma may be due to the prolonged acidic environment in the surrounding tissues. The final explanation for the failure of the MTA may relate to the sensitivity of the material to various techniques. Factors such as inadequate condensation, moisture contamination, or premature occlusal loading could have compromised the material's matrix. However, considering the absence of symptoms for 18 months and the subsequent failure following a new trauma, environmental degradation appears to be the most likely cause.

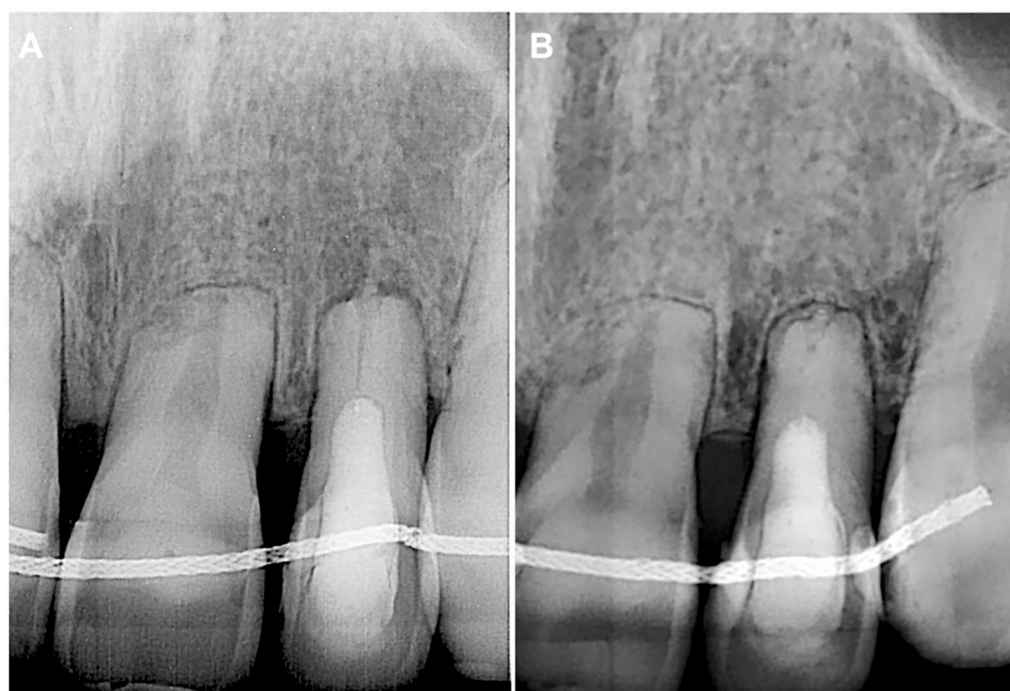
FIGURE 4

(A) Three-month follow-up periapical radiograph revealing a completely healed periapical lesion on tooth 22. (B) Four-year follow-up periapical radiograph demonstrating no signs of periapical pathology.

At the 3-month follow-up, the patient had no complaints, and no signs of endodontic pathology were observed. The follow-up radiograph showed periapical healing (Figure 4A). The next follow-up was scheduled for 6 months.

The patient returned after 4 years for endodontic treatment on a different tooth and reported no complaints for tooth 22. The absence of clinical signs for tooth 22 was equally followed by the complete healing of periapical tissues radiographically (Figure 4B).
