VILNIUS UNIVERSITY

PECULIARITIES OF ULTRASTRUCTURE  
OF TOOTH ROOT CANALS TREATED  
WITH RESORCINOL FORMALDEHYDE,  
EVALUATION OF INFLUENCE OF ENDODONTIC  
RETREATMENT PROCEDURES  
AND RESISTANCE TO FRACTURE.  
*STUDY IN VITRO*

Summary of Doctoral Dissertation

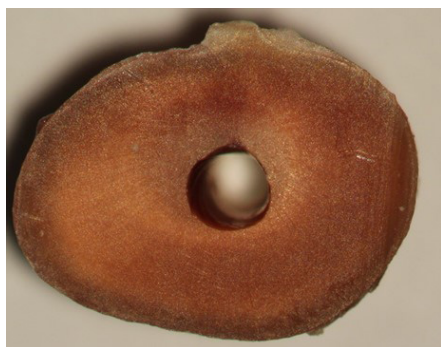
**Figure 1.** No defect

The following scheme for recording root defects was prepared, where the number of dentin defects in each specimen surface was recorded (if there were no defects – 0; if some defects were present, numbers 1, 2, 3, etc. were ascribed). Four types of defects were singled out for the evaluation. No defect – root dentin devoid of any cracks or lines (Figure 1). In complete fractures, the line extended from an inner root canal wall to an outer root surface (Figure 2). In incomplete (partial) fractures, the line started from an outer or inner root surface but it did not extend throughout the whole dentin surface (Figure 3). In intradental fractures, the line was localized inside the dentin without reaching the outer or inner surface of the root (Figure 4).

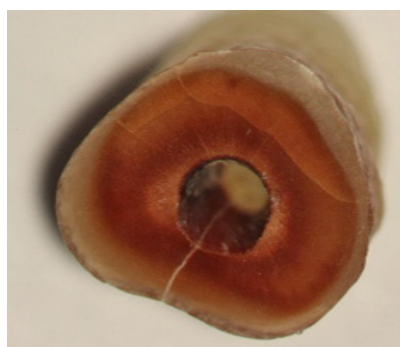
**Figure 2.** Complete fracture

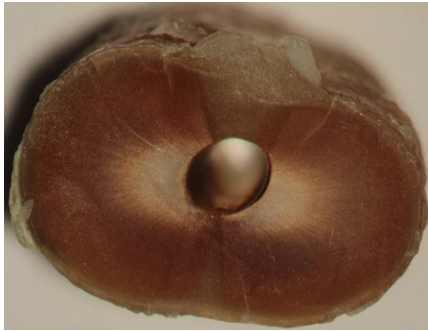
**Figure 3.** Incomplete fracture

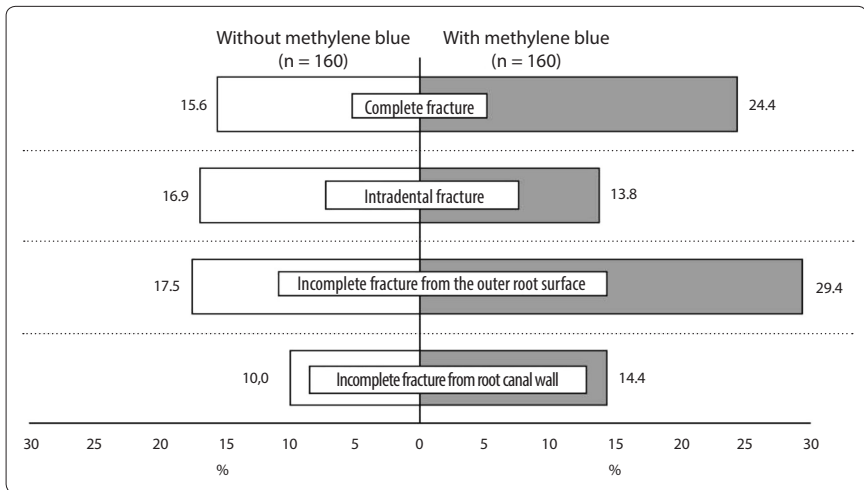
The percentage distribution of cracks in coronal third cross-section of the root is shown in figure 6. There were statistically significantly more complete fractures ( $p=0.05$ ) and incomplete fractures from the outer root surface ( $p=0.01$ ) in cases where methylene blue was used.

**Figure 6.** The percentage of cracks of root coronal surface
